November 17, 2003
Investigation: # 03NE022

Farmer Electrocuted Exiting Grain Bin

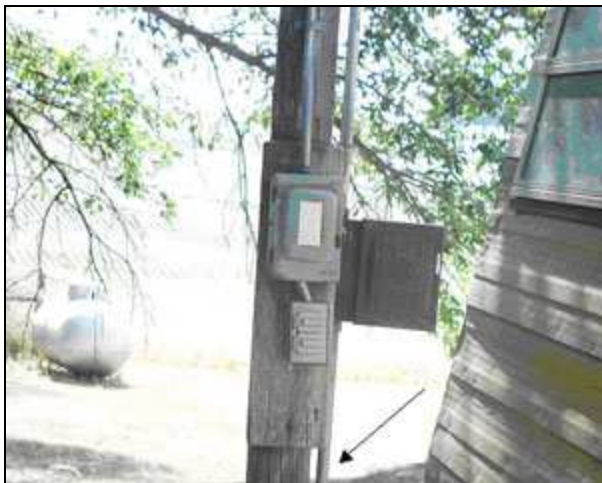
Electrical Power Source: Power for the auger (110 volts) originated from a power pole (see [picture # 1](#)) located near the house. This pole and pull box were installed during the late 1940s. Knockout plug holes had not been covered, allowing birds to build inside the box (see [picture #2](#)).

Picture #1: Pull box with conduit running to grain bins.

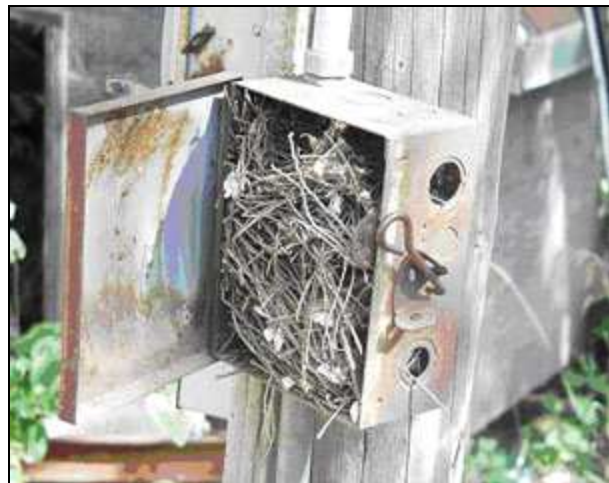
Discussion: The pull box located near the house had several of the knock-out plugs missing, which allowed birds to fill it full of nesting materials. If an attempt had been made to shut the

box off at this location, chances are good that the actions would have been blocked due to the extreme amount of materials inside. The pull box located between the bins also had knockouts removed. The duplex box attached to the bottom was missing one of the receptacles and also the cover plate. Both the black flexible extension cord from the pull box, and also the cord hard wired into the electrical auger motor had numerous areas where the external insulation had cracked and been taped over with black electrical tape. Black electrical tape does not have the same insulating properties as the original insulation. There were also areas on the motor wire where the internal insulation surrounding the copper wiring was exposed. The male end of the black extension cord was missing the protective insulation wafer that fits over the two prongs.

Picture #2: Pull box between house and corn bins with nesting materials.

Suggestion: Remove equipment from service that has damaged electrical cords, missing ground prongs, and/or missing or cracked insulation.

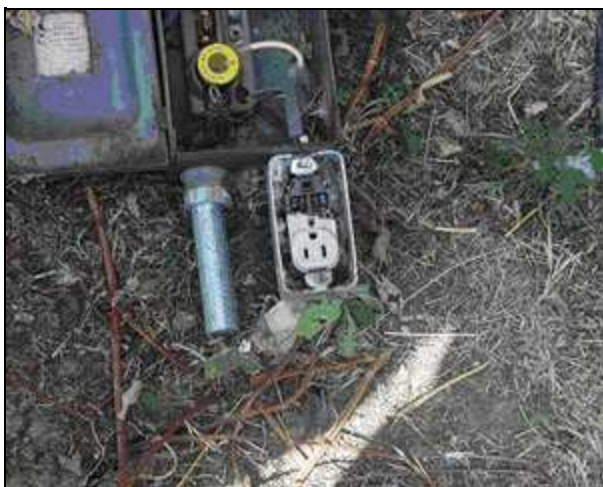
The wiring runs approximately 88 feet underground through metal conduit to another pull box located between the two grain bins (see [pictures #3 & 8](#)). This box contained a 30 amp screw-in type fuse (see [picture #3](#)). A duplex metal outlet box had been attached to the bottom of the pull box. It was wired using the same 10-gauge wiring.

The owning power company personnel arrived within 5 minutes. They shut off the power at the pull box between the bins by pulling down on the handle. The crew leader stated that the 30 amp installed fuse had not blown, thereby allowing continual power to pass to the victim prior to his son unplugging the auger. Rescue personnel removed the victim from the bin.

Picture #3: Pull box that was between bins, removed after incident.

Discussion: At the time of construction, there were no federal, state or local requirements for grounding grain bins or installed electrical service beyond the service entrance. Since the incident, the breaker box between the bins has been grounded by inserting the ground wire into the ground. To check if this is a proper ground, the servicing power company should be contacted to conduct a test to ensure its adequacy.

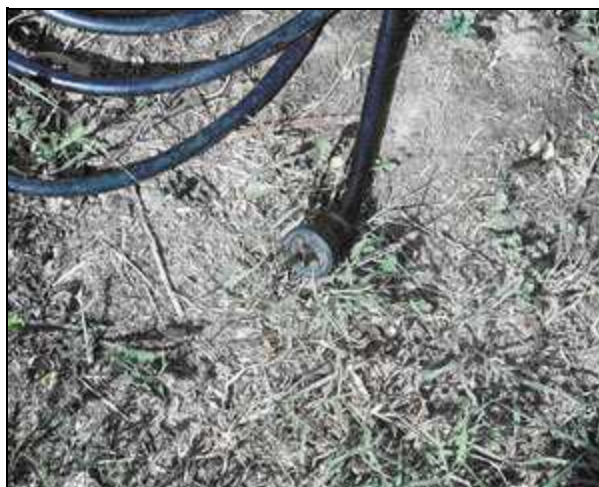
A black flexible electrical cord was then plugged into the outlet box. The male end of this cord was the older two-pronged style with no ground prong (see [picture # 4](#)). The female end of the flex cord had another metal duplex outlet box attached (see [picture #5](#)).

Discussion: Both cord male ends were the old two-prong style. The black cord's male end was missing the protective insulating wafer. Neither of the duplex outlets attached to the pull-boxes had protective covers. The duplex outlet box attached to the black extension cord was made for indoor use only and should never be used outdoors. Any time a fixture that is intended for inside use is used outside there is a high probability that moisture will enter the fixture through the manufactured cutouts, holes, etc. Fixtures intended for outside use do not have these openings and are made to withstand extreme environments.

Picture #4: Black extension cord male end.

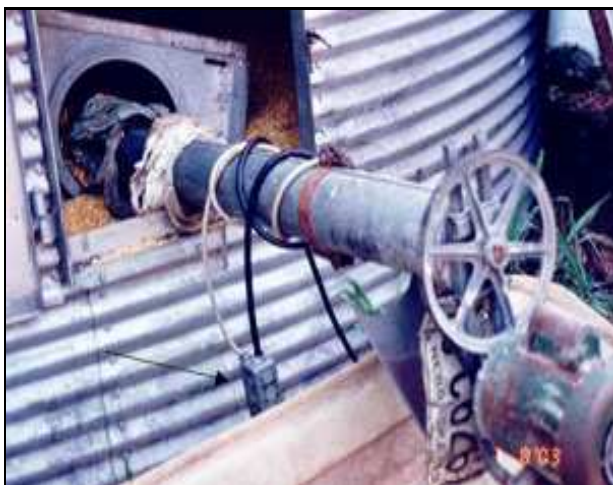
Picture #5: Black extension cord female end.

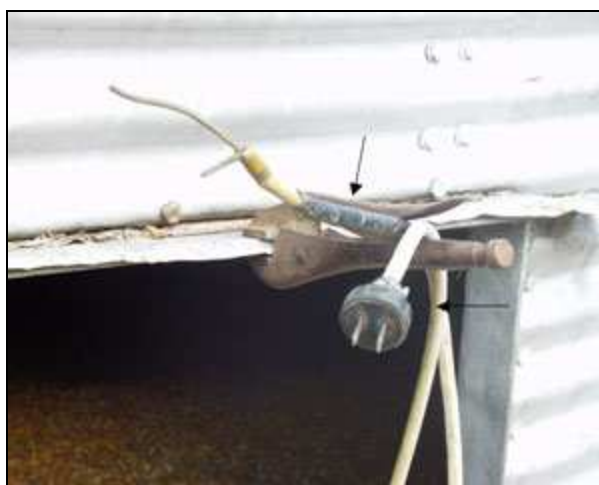
The portable auger was wired with a flexible two-wire cord (see [picture # 6](#)), connected internally to the motor. The male end was the two-pronged older style.

Picture #6: Portable auger motor cord.

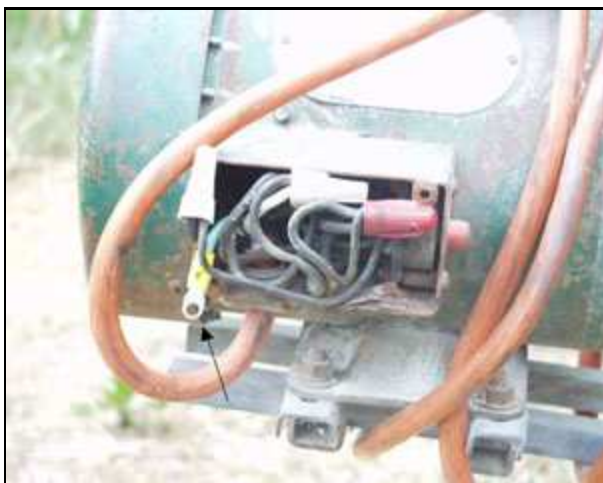
Several days afterwards the victim's father and brother dismantled the portable auger's electric motor. They stated that there was a bare wire touching the inside case, which had caused the motor to become energized. They repaired the bare wire, and also installed a new flexible cord with the ground wire attached to the motor housing plate (see [picture #7](#)). The old pull box between the bins was replaced with a newer breaker style box. A ground wire was run from the new box directly into the ground underneath in an attempt to establish a ground. The servicing electrical company was going to be contacted to inspect the grounding system. The victim's spouse stated that once the bins were emptied, they would be torn down.

Picture #7: Portable auger motor housing opened with new ground wire.

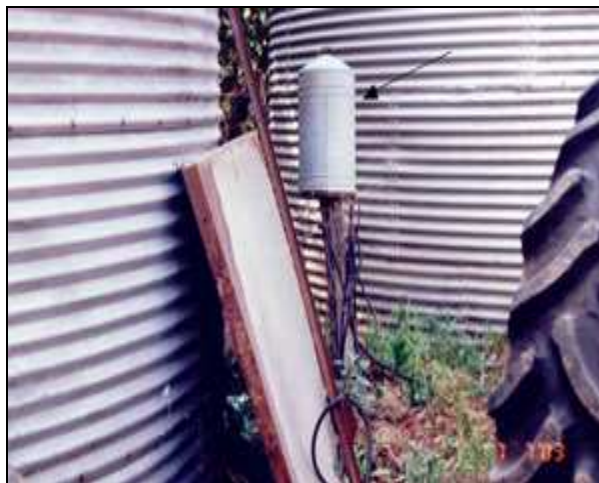
Picture #8: Pull box between bins day of incident with protective covering.
