Electrical Safety Information

Investigation: # 03NE022

Farmer Electrocuted Exiting Grain Bin

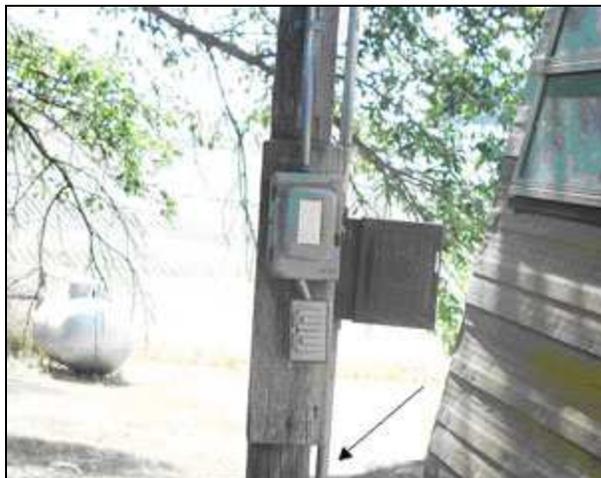
Electrical Power Source: Power for the auger (110 volts) originated from a power pole (see [picture # 1](#)) located near the house. This pole and pull box were installed during the late 1940s. Knockout plug holes had not been covered, allowing birds to build inside the box (see [picture #2](#)).

Picture #1: Pull box with conduit running to grain bins.

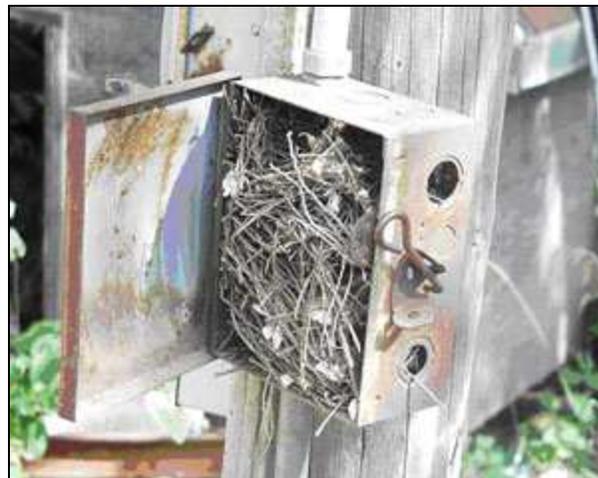
Discussion: The pull box located near the house had several of the knock-out plugs missing, which allowed birds to fill it full of nesting materials. If an attempt had been made to shut the

box off at this location, chances are good that the actions would have been blocked due to the extreme amount of materials inside. The pull box located between the bins also had knockouts removed. The duplex box attached to the bottom was missing one of the receptacles and also the cover plate. Both the black flexible extension cord from the pull box, and also the cord hard wired into the electrical auger motor had numerous areas where the external insulation had cracked and been taped over with black electrical tape. Black electrical tape does not have the same insulating properties as the original insulation. There were also areas on the motor wire where the internal insulation surrounding the copper wiring was exposed. The male end of the black extension cord was missing the protective insulation wafer that fits over the two prongs.

Picture #2: Pull box between house and corn bins with nesting materials.

Suggestion: Remove equipment from service that has damaged electrical cords, missing ground prongs, and/or missing or cracked insulation.

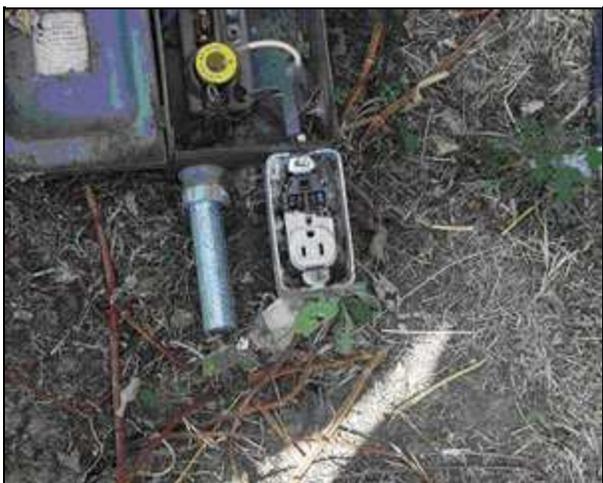
The wiring runs approximately 88 feet underground through metal conduit to another pull box located between the two grain bins (see [pictures #3 & 8](#)). This box contained a 30 amp screw-in type fuse (see [picture #3](#)). A duplex metal outlet box had been attached to the bottom of the pull box. It was wired using the same 10-gauge wiring.

The owning power company personnel arrived within 5 minutes. They shut off the power at the pull box between the bins by pulling down on the handle. The crew leader stated that the 30 amp installed fuse had not blown, thereby allowing continual power to pass to the victim prior to his son unplugging the auger. Rescue personnel removed the victim from the bin.

Picture #3: Pull box that was between bins, removed after incident.

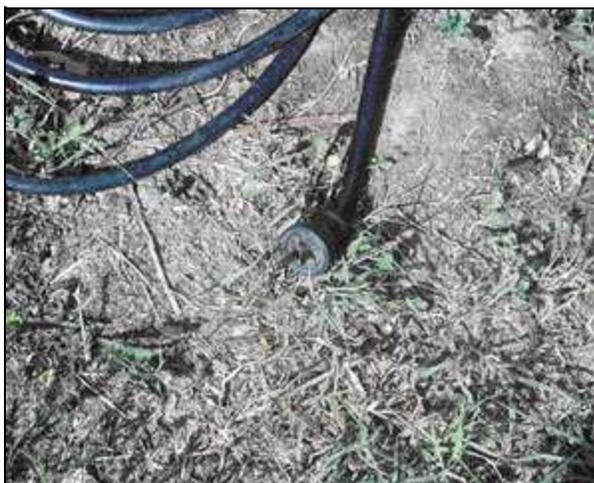
A black flexible electrical cord was then plugged into the outlet box. The male end of this cord was the older two-pronged style with no ground prong (see [picture # 4](#)). The female end of the flex cord had another metal duplex outlet box attached (see [picture #5](#)).

Discussion: Both cord male ends were the old two-prong style. The black cord's male end was missing the protective insulating wafer. Neither of the duplex outlets attached to the pull-boxes had protective covers. The duplex outlet box attached to the black extension cord was made for indoor use only and should never be used outdoors. Any time a fixture that is intended for inside use is used outside there is a high probability that moisture will enter the fixture through the manufactured cutouts, holes, etc. Fixtures intended for outside use do not have these openings and are made to withstand extreme environments.

Picture #4: Black extension cord male end.

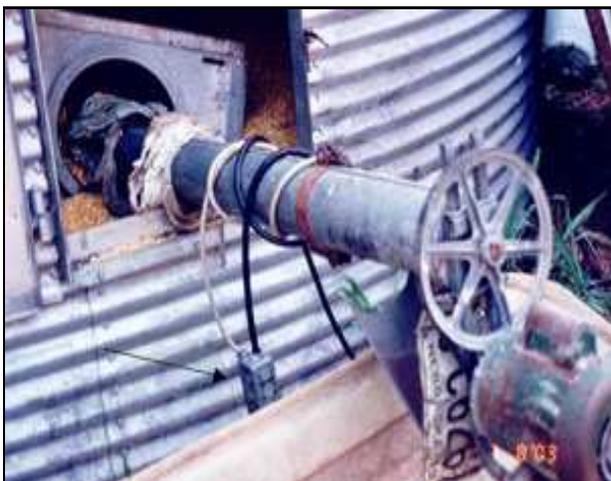
Picture #5: Black extension cord female end.

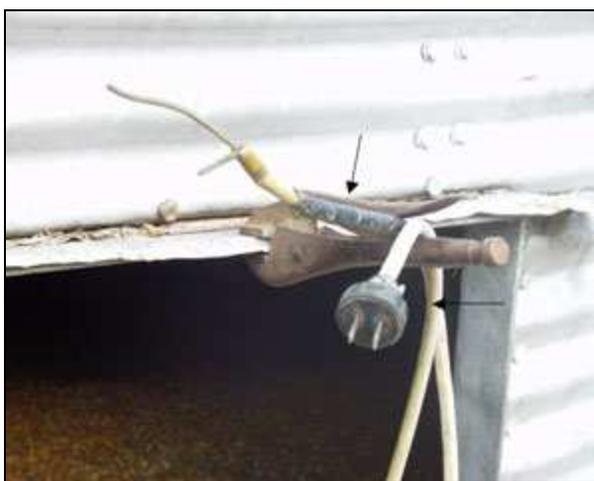
The portable auger was wired with a flexible two-wire cord (see [picture # 6](#)), connected internally to the motor. The male end was the two-pronged older style.

Picture #6: Portable auger motor cord.

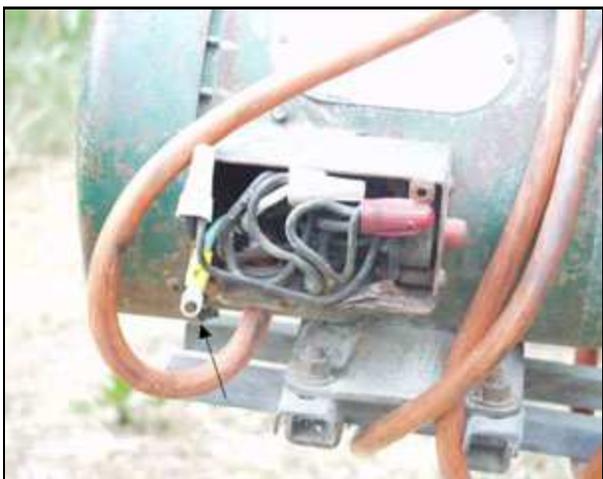
Several days afterwards the victim's father and brother dismantled the portable auger's electric motor. They stated that there was a bare wire touching the inside case, which had caused the motor to become energized. They repaired the bare wire, and also installed a new flexible cord with the ground wire attached to the motor housing plate (see [picture #7](#)). The old pull box between the bins was replaced with a newer breaker style box. A ground wire was run from the new box directly into the ground underneath in an attempt to establish a ground. The servicing electrical company was going to be contacted to inspect the grounding system. The victim's spouse stated that once the bins were emptied, they would be torn down.

Picture #7: Portable auger motor housing opened with new ground wire.

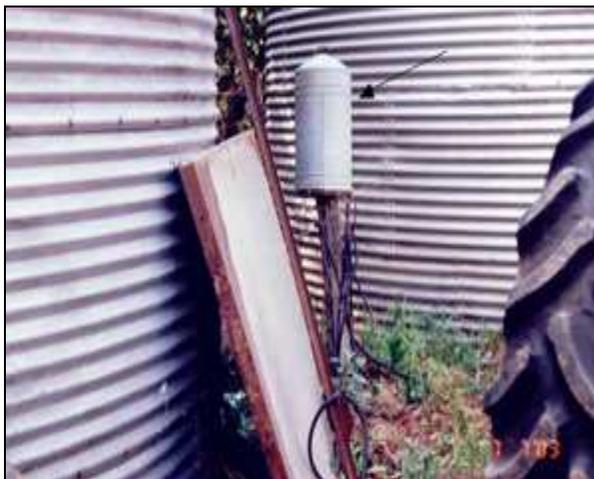
Picture #8: Pull box between bins day of incident with protective covering.
